CASE STUDY

Leaking Earth Wall Dam Stabilised

Location: Penguin, Tasmania

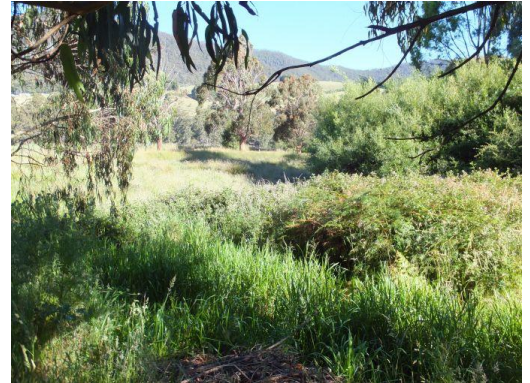
The farm has an earthen-wall dam that has been leaking for many years. The leakage has made the wall potentially unstable, and has made the land at the base of it unworkable.

Note the luxuriant weed growth at the base of the wall.

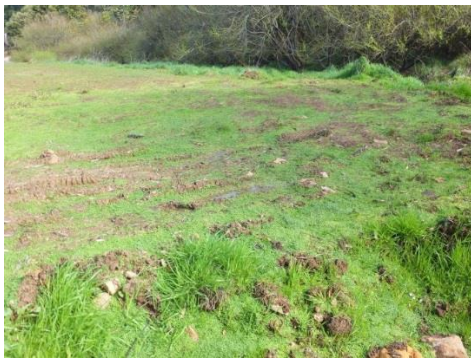
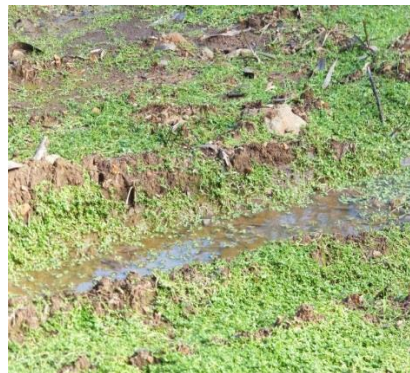
The same area after being cleared and many extra loads of dirt added to increase land elevation.

The owner dug a trench to take water away but water continued to seep into the trench at the base of the wall.

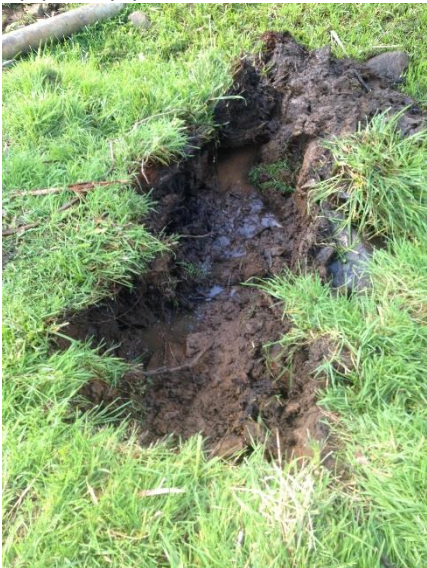
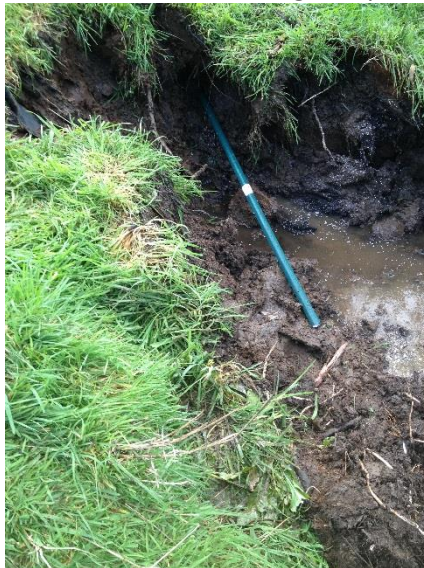
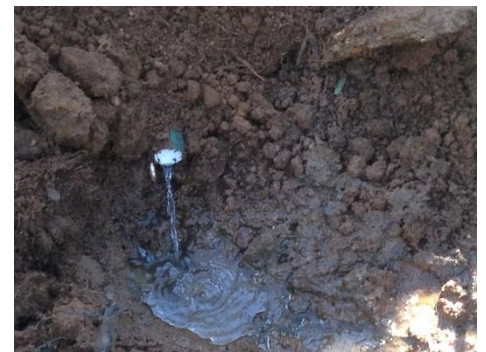
The Western End

The western end of the dam wall presented a challenge because it appeared that the water was coming down from the adjacent hillside, but a test excavation into the seepage area showed that it was, indeed, coming from the dam wall itself.

The excavation was widened a little before a PVC pipe (with an end cap) was forced into the wall on a slight upward angle as a casing. Two lengths of Capiphon pipe were inserted into this casing and given a sharp tap with a block of wood to dislodge the end cap of the casing before the casing was withdrawn leaving the soil to collapse around the Capiphon pipe. The excavation was then backfilled with the original spoil.
