# CASE STUDY

## Rock Seepage into Outside Laundry & Courtyard

**Location:** Hampden Road, Battery, Tasmania

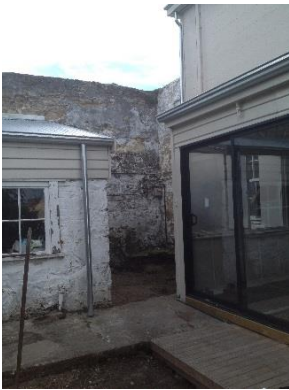
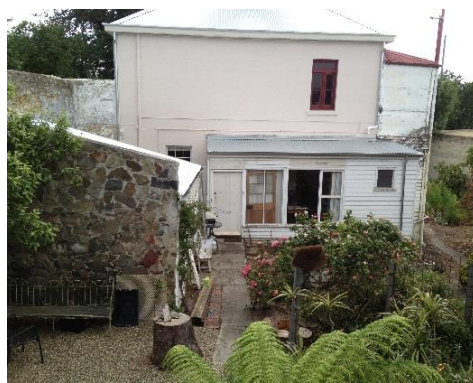
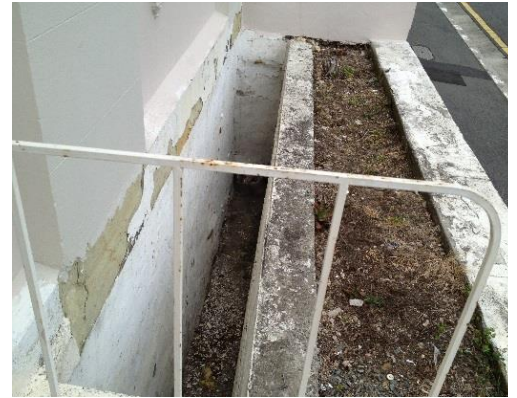
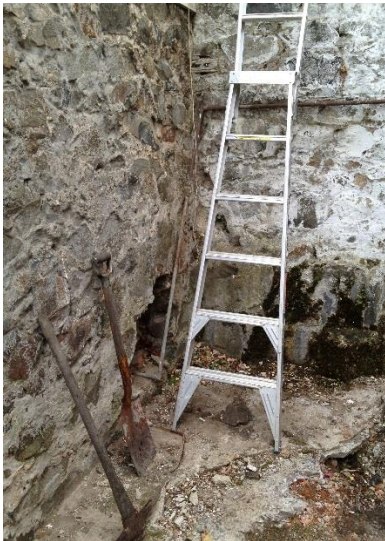
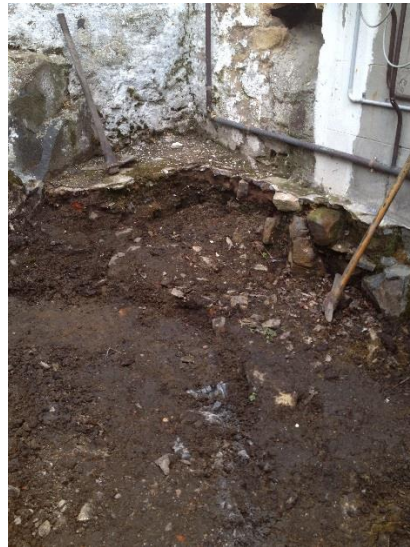
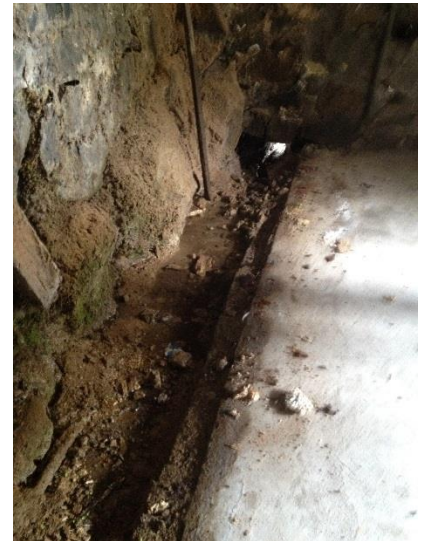
The house has been built on a rock bench at the foot of the old Hobart foreshore. Water seeps through the sandstone cliff face into the old outside laundry and into a partly enclosed courtyard. In heavy rain water flows from a deep drain (the Moat) designed to keep it away from the front of the house.

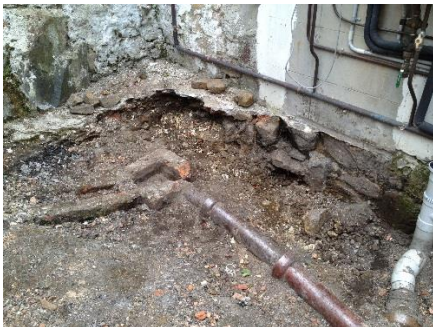
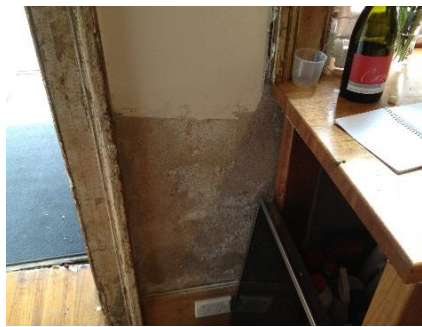
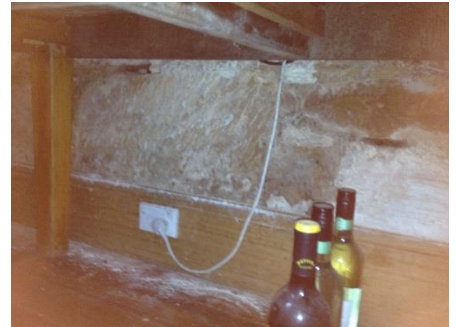
Despite attempts to control the situation with surface and sub-surface drainage, water has seeped under and through the sandstone foundations over the years causing rising damp in the ground floor rooms.

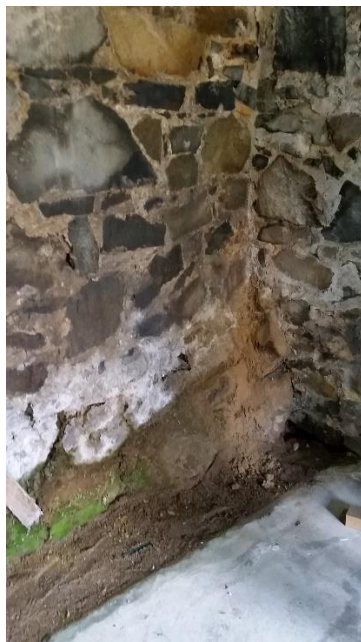
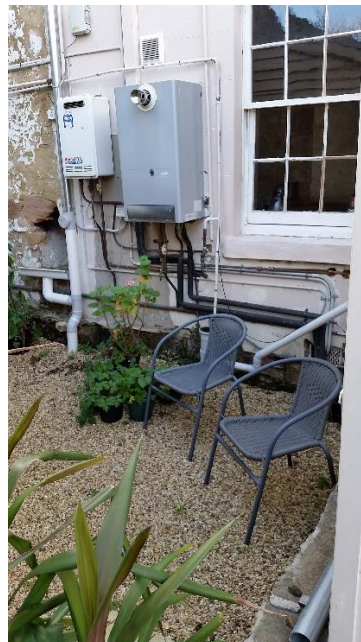
- Dry laundry floor.
- Usable courtyard.
