# CASE STUDY

## Dealing with a broken stormwater pipe

**Location:** South Hobart Primary School, South Hobart

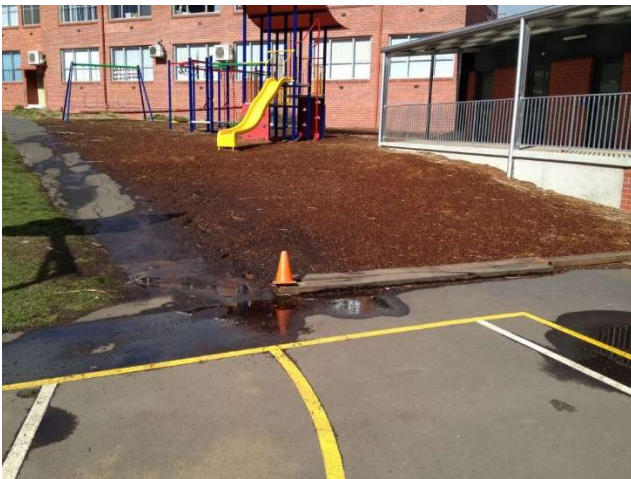
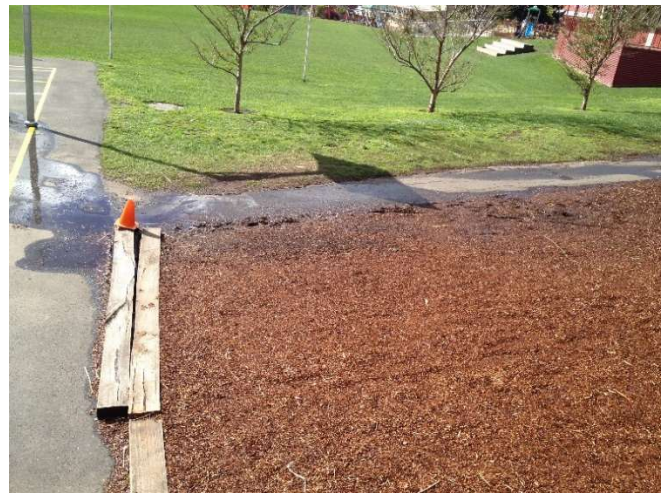
Whenever it rained, and for days later, water flooded out from the playground at the South Hobart Primary School. It not only made the soft-fall area unusable but flooded across the basketball courts. It was suspected that heavy equipment brought in during construction of a new gymnasium adjacent to the existing buildings had cracked the stormwater pipes, most likely in two different places.

Available drainage plans were vague but inspection of a nearby stormwater sump pit showed that pipes coming into it from the direction of the playground were dry, suggesting that the subsurface drains were not functional, either broken or blocked.

An independent drainage contractor confirmed the diagnosis and provided a **quote of \$3,288** to install new ag pipe based intercept drain across the top of the playground.

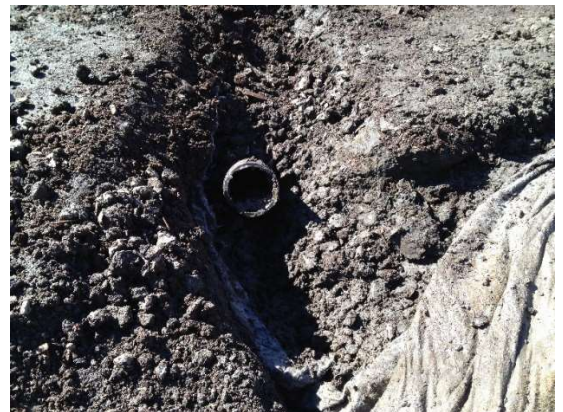
A small, exploratory excavation revealed that there was, indeed, an existing ag pipe at the bottom of the playground heading in the direction of the sump pit. It also revealed that the ag pipe was partially blocked, and that the geotextile fabric covering the pipe appeared to be also blocked with soil.

The contractor said that he would also replace this drain.

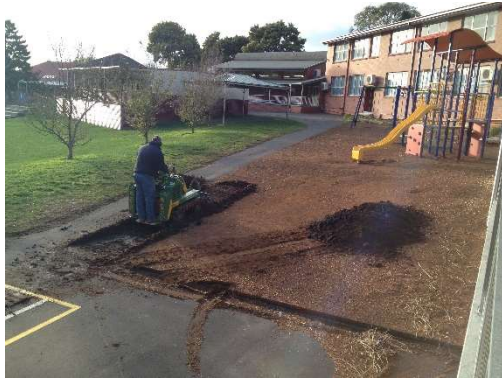
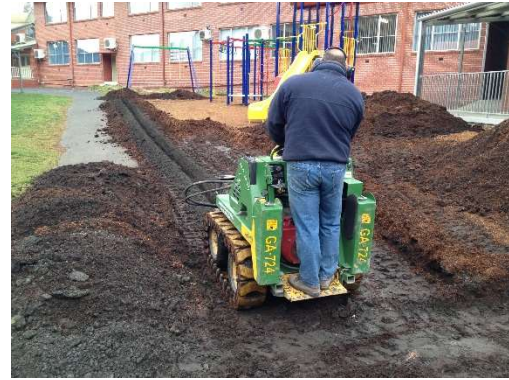
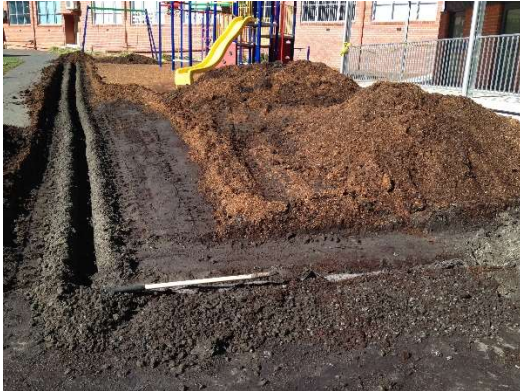
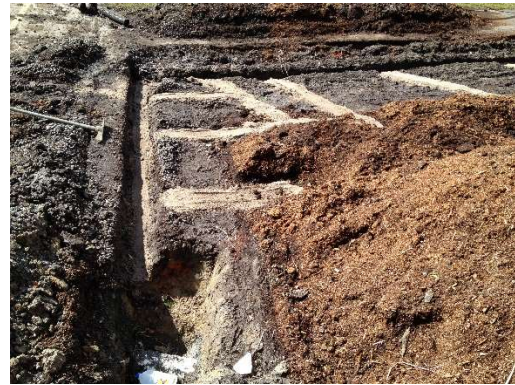
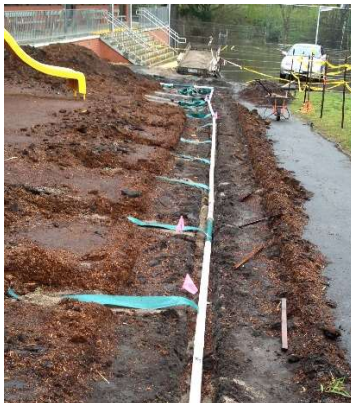
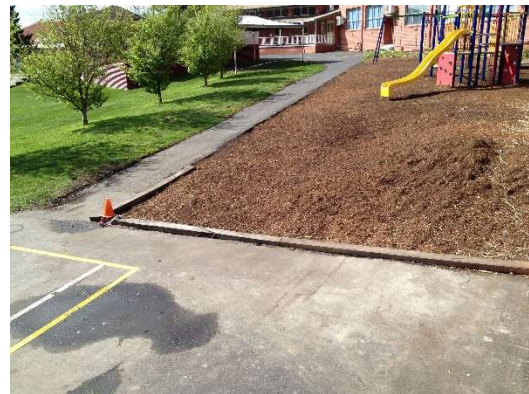
It was apparent that the stormwater was welling up through the soil in more than one place. It was decided that Capiphon could be installed directly on the clay underneath the soft-fall to intercept this water.
