CASE STUDY

New and Existing Retaining Walls (after landslide)

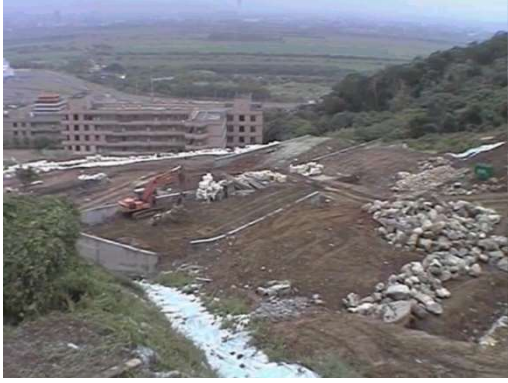
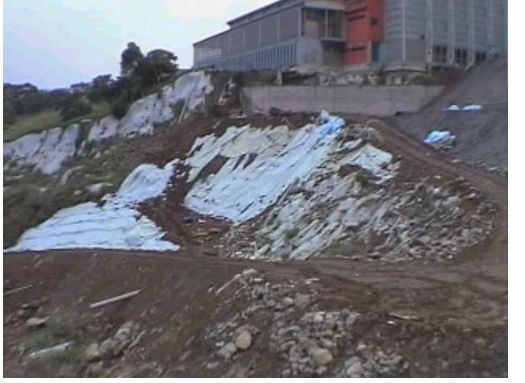
Client Name:	University of Arts
Client Address:	Taiwan
Job Start:	2000
The situation:	<p>The site was suffered from a serious typhoon rain causing huge area of land slide. The buildings uphill were imminently endangered. Also, the local ground water contains minerals like iron oxide which will cause blockage for any traditional drain materials very quickly.</p> <div style="display: flex; justify-content: space-around;">

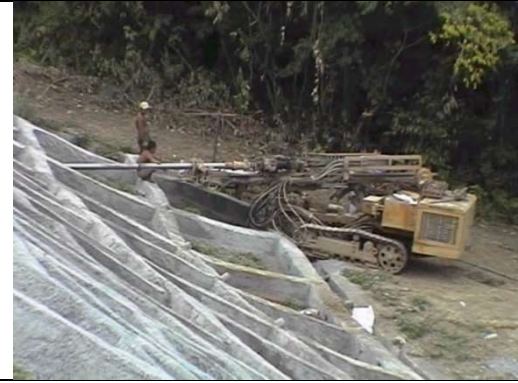
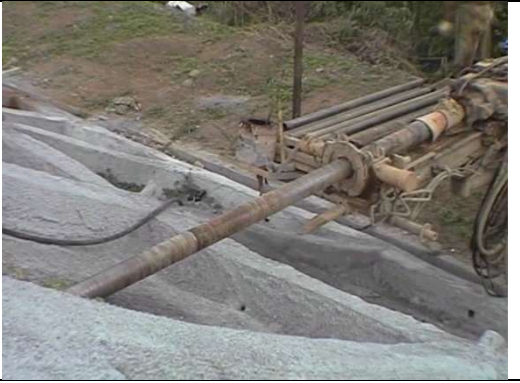
</div>
The solution	<p>Several fence of walls were constructed. The upper walls use back wall drainage. The photo showed that all traditional pipes failed and Capiphon pipes remain draining.</p> <div style="display: flex; justify-content: space-around;">     </div> <p>Holes were drilled into the existing walls to insert Capiphon drain pipes up to 10 meters deep. But the consultant was not so confident with Capiphon. So, he specified that 2- traditional pipes were used in between the Capiphon pipes.</p> <div style="display: flex; justify-content: space-around;">

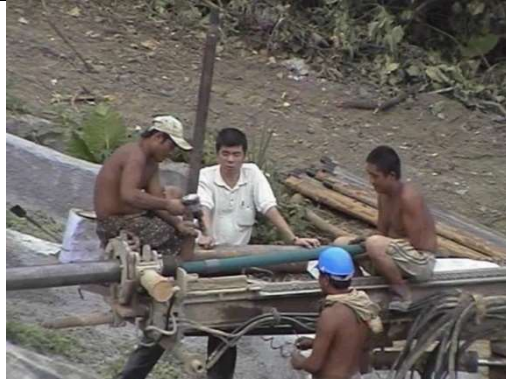
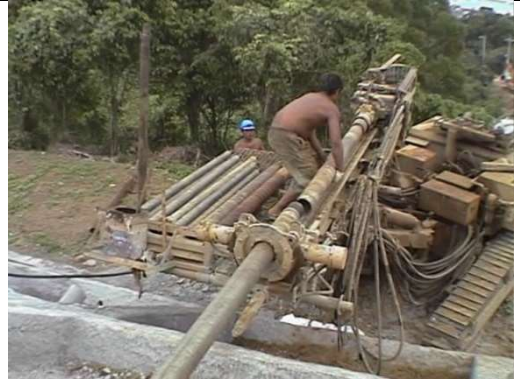
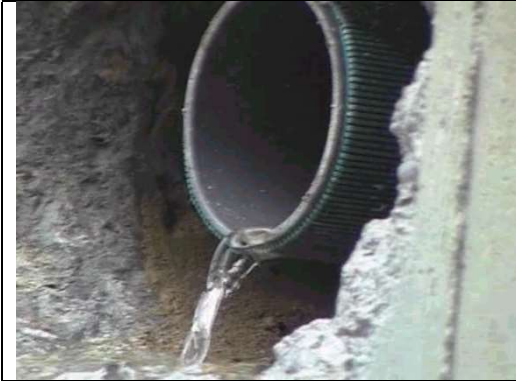
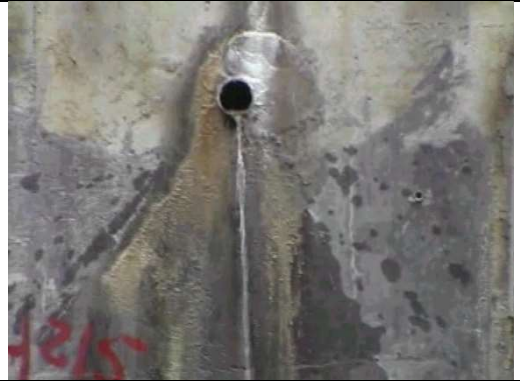
Four years later, the water running from the Capiphon pipes was clear, even though there was obvious mineral deposits outside the outflow pipe occurring as the minerals in the water were oxidised in contact with the air.

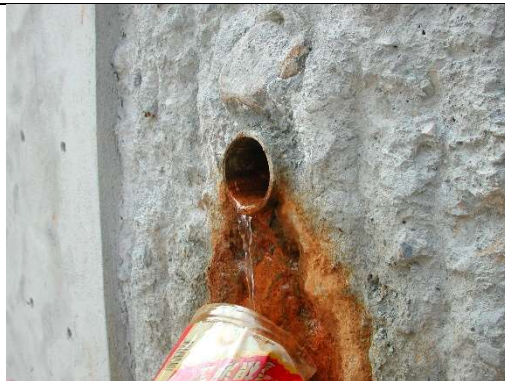
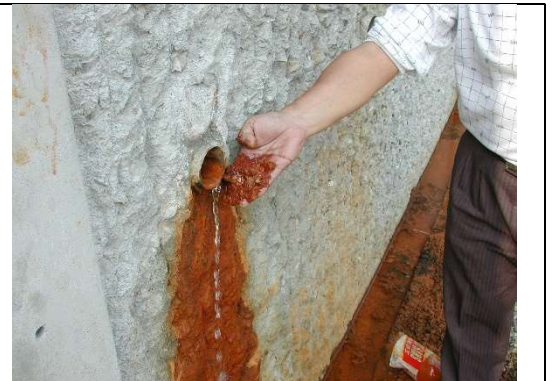
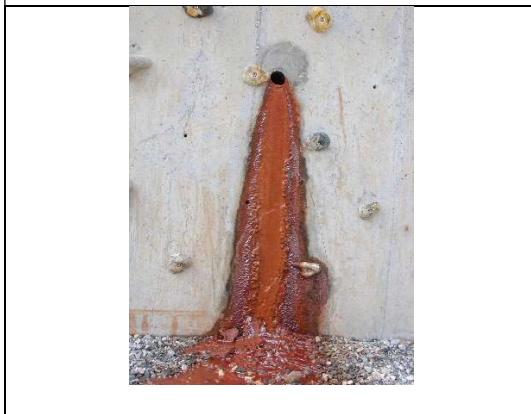
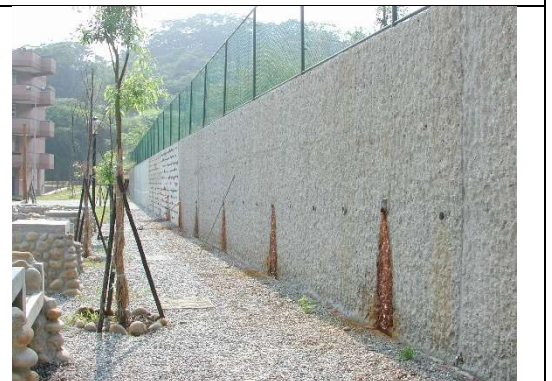
Equally obvious is the fact that there has been no flow from the conventional pipes.
