# CASE STUDY

## Waterlogged Pasture Made Usable

**Location:** Penguin, Tasmania

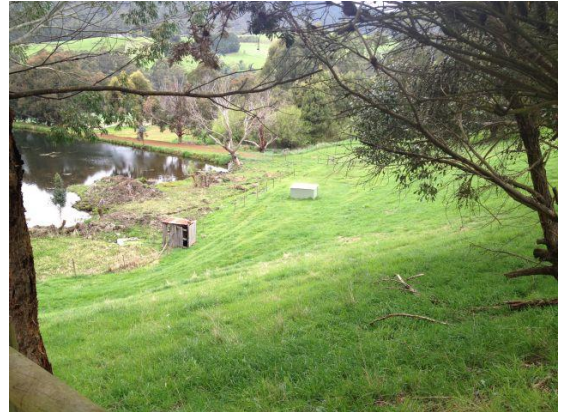
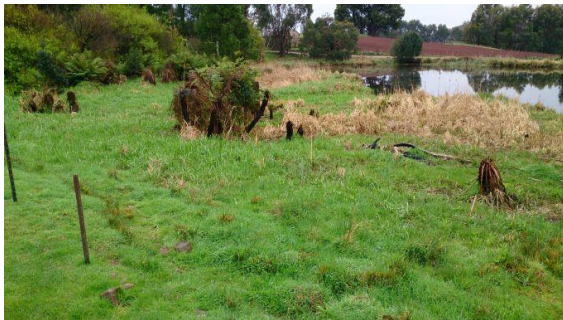
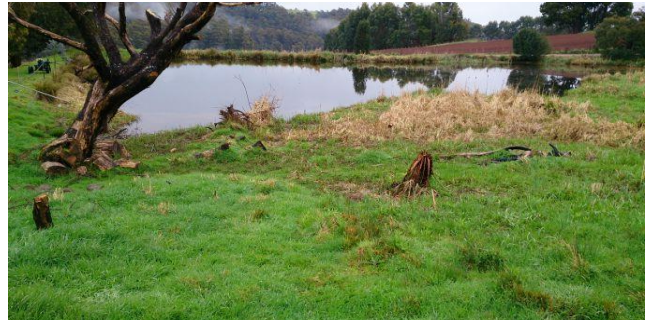
A number of natural springs flow out from the hill above a dam that has been constructed to take advantage of the constant flow of water.

The owner has attempted to reclaim the bank of the dam by removing the reeds and deepening the dam by dredging. His plan is to create an attractive recreational water feature, as well as a means of controlling the run-off.

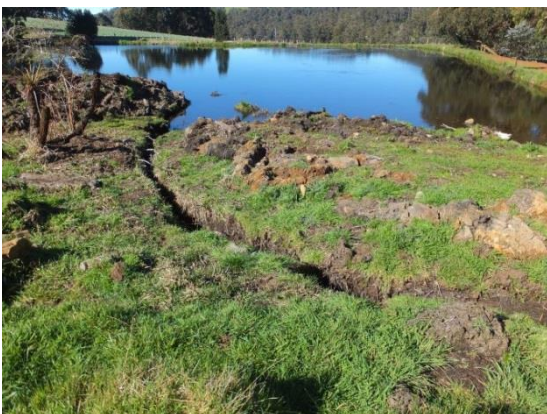
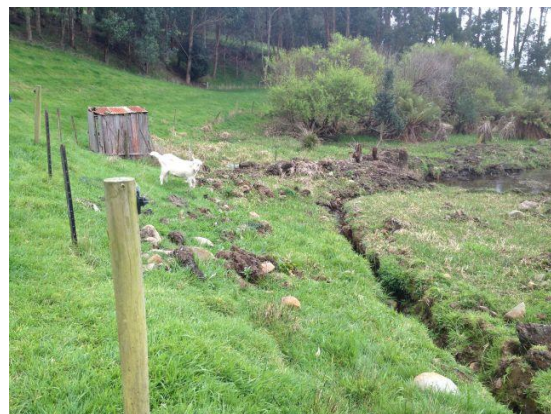
The owner decided to drain the base of the hillside by digging trenches across the slope and then running them down into the dam. This created two further problems; the trenches collapsed and filled with soil, and the trenches took up a lot of usable space.

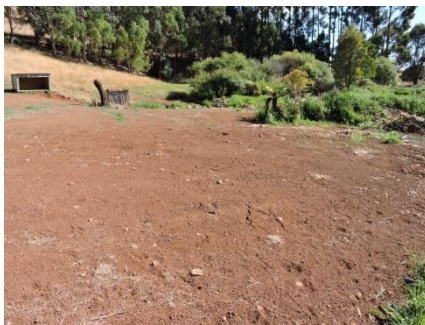
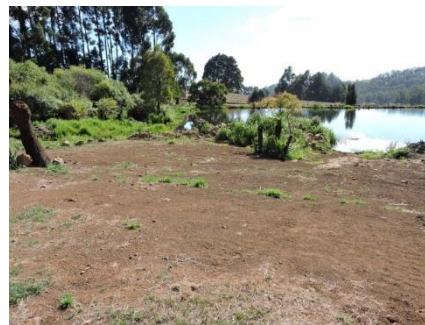
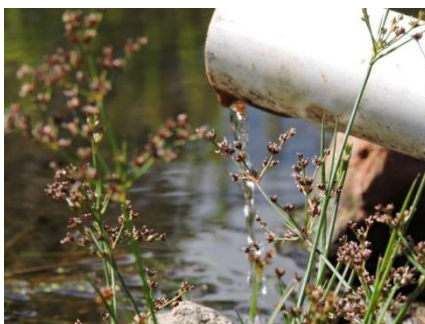
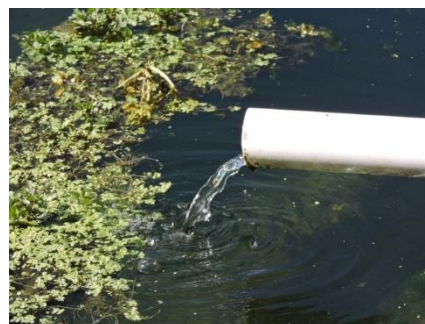
- Base of the hill stabilised.
- Land below the wall is now trafficable.
- More usable land available.
