CASE STUDY

Flooded Vegetable Garden

Location: Northlakes High School, San Remo, Central Coast of NSW,

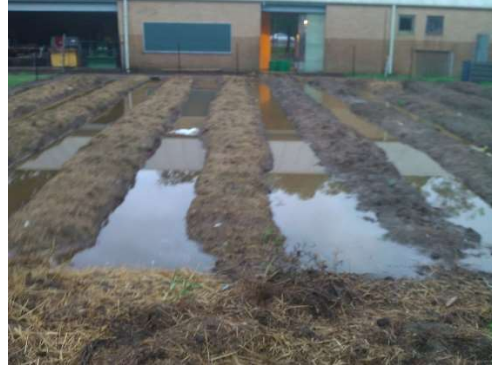
Agriculture block on school...heavy pooling after rain in between the raised vegetable gardens...pooling lasted for weeks making the gardens untenable.

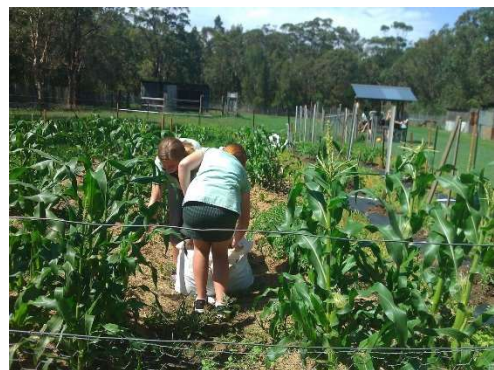
After installing Capiphon, the pooling drains away within 24 hrs with the ground being dry enough for the students to walk on within 48 hrs.
