# CASE STUDY

## Keeping the Hot Tub Dry

### Capiphon Drainage Under Spa

**Location:** South Arm, Tasmania

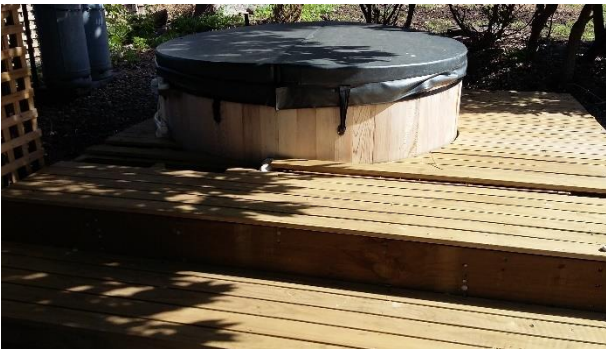
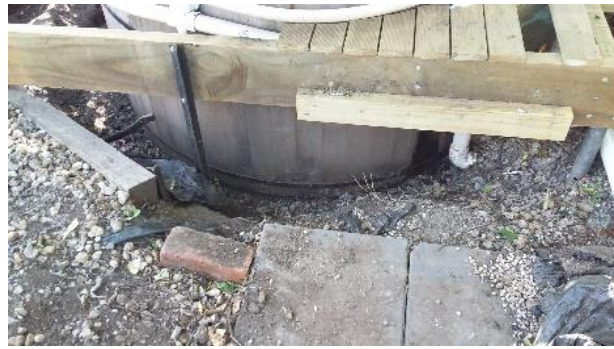
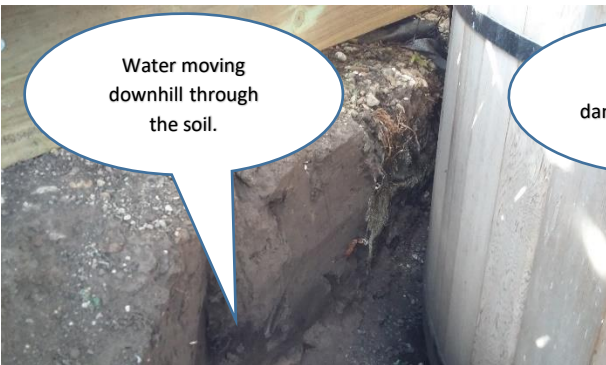
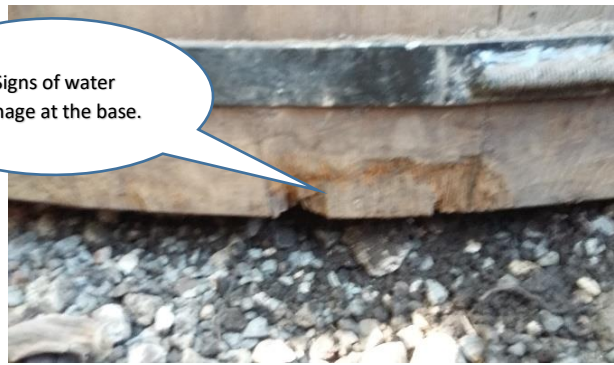
Poor drainage over the years had led to a soggy base under the Hot Tub which, in turn, led to the timber of the tub starting to rot. Water may also have been coming down through the cut into the embankment to add to water splashed out during use. Capiphon belts under paving solved the problem.

The tub was removed to one side, the site levelled and a layer of FCR compacted as a firm base.
