# CASE STUDY

## ON THE EDGE: Capiphon overcomes space restriction

**Location:** West Hobart

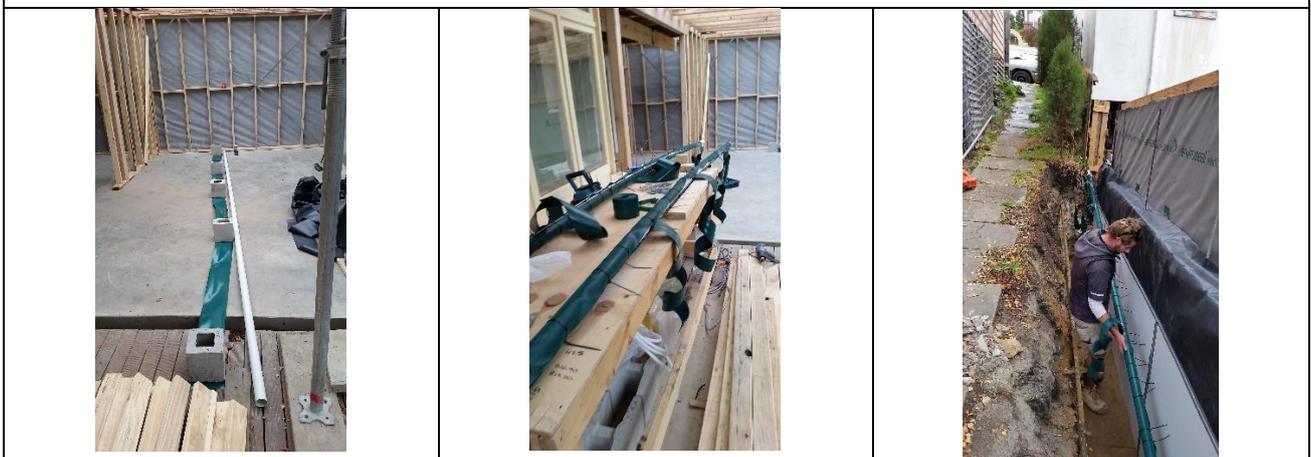
Capiphon Pipe being fabricated on site before being laid on a thin layer of coarse sand.

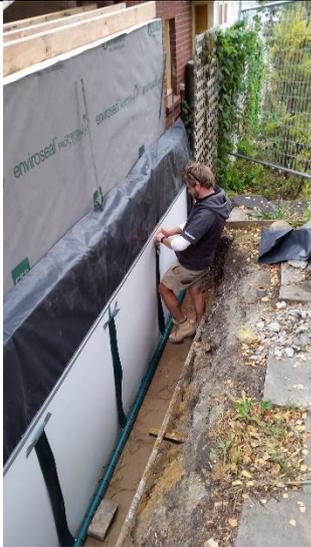
Strips of Capiphon Belt inserted into the Capiphon Pipe, and taped to the core flute sheets.

Given, too, the slope and the permeability of the rock stratum, it was decided to take a "belt and braces" approach with strips of Capiphon Belt running down the wall and into the Capiphon Pipe.

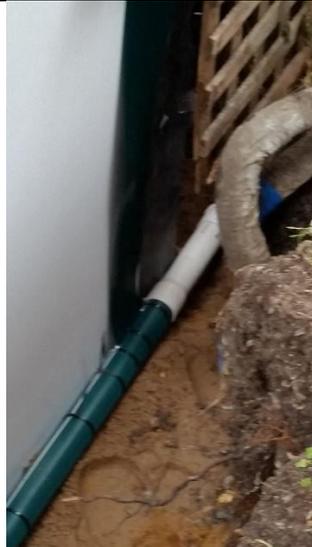
The Capiphon Pipe plugs into the special connector to join the stormwater system.

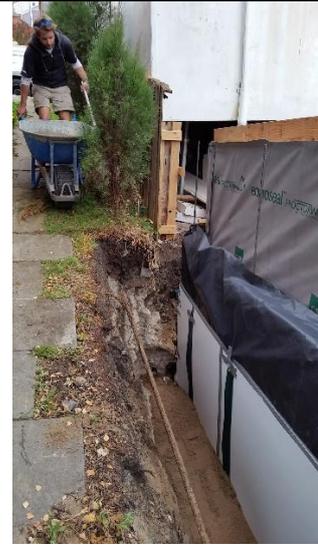
Covering the Capiphon Pipe with coarse sand before backfilling the trench.

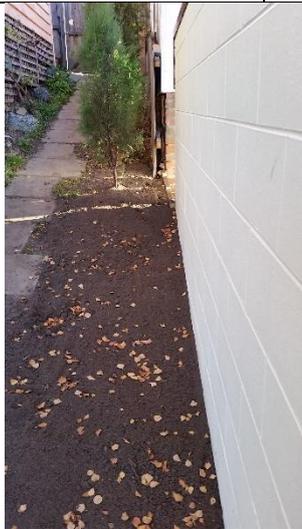
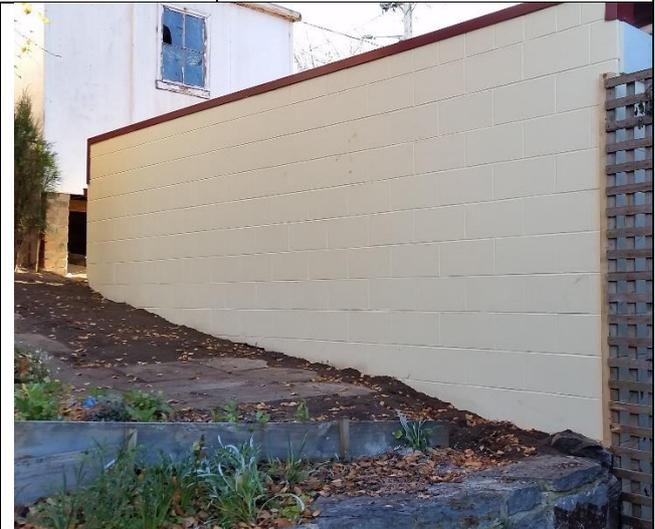
**The finished wall with just 40mm of space lost.**

The owners wanted to rebuild the room on the same footprint and wanted to maximise the usable space. The designer ([John Weston Architectural Design](#)) had previously used Capiphon in a similar situation so suggested to the owners to pull the building in from the boundary by 40mm, sufficient to allow for a Capiphon pipe to be used.
