CASE STUDY

Overcoming Gravity with Capiphon

Location: Swan Street, Richmond, Victoria

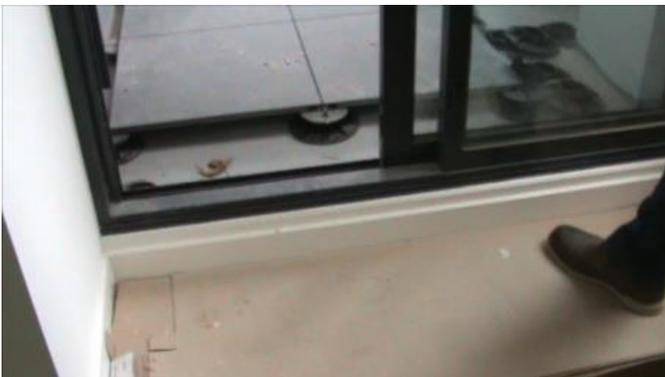
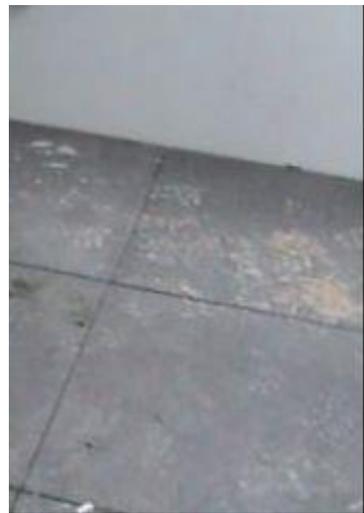
The balconies of a new apartment block remained flooded after rain. It was apparent that the outlet drain sat above the floor of the balcony. This may not have been considered to be a major problem because a tile floor was to be suspended on adjustable pads, concealing the water on most balconies. However, on some, the water level was so deep that a residue of silt remained on the tiles after the rain event.

Above: The suspended tiles on the apartment balcony. Below: Silt on the tiles, and water pooled under the tiles.

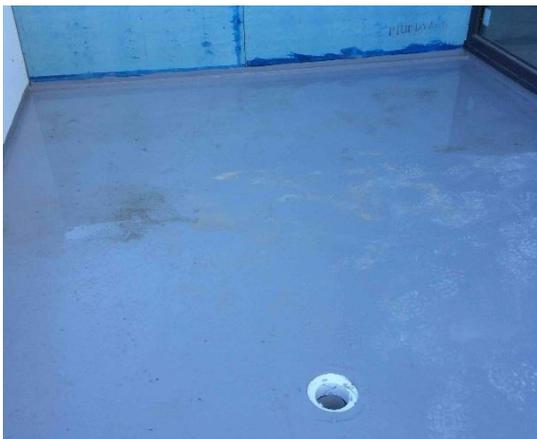
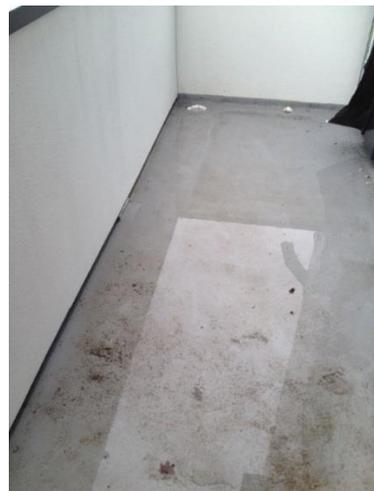
In any case, the project manager was unhappy about having water pooling there under the tiles for a significant period of time.

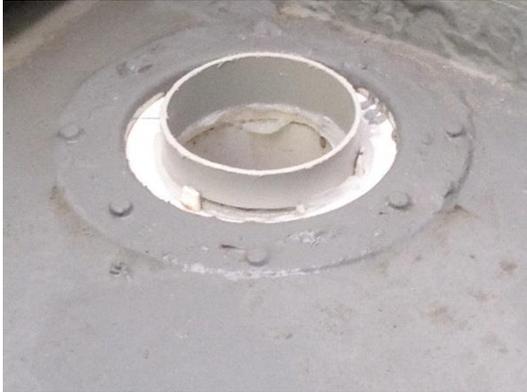
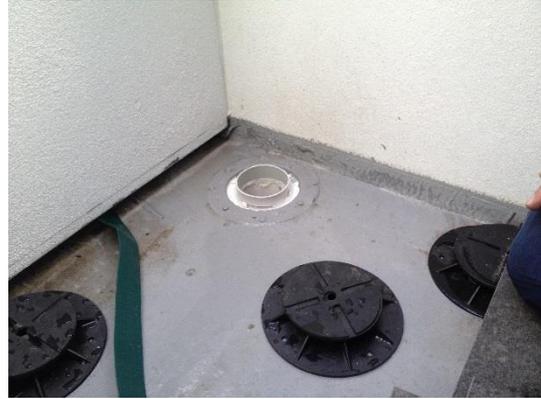
It has been established that Capiphon belt will start syphoning when subject to a 10mm head, so an connector was devised to create a head to start water flowing in the belt, and to take the belt into the balcony drain to create a syphon head.

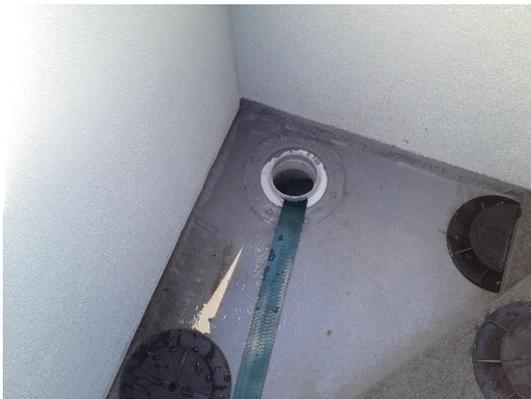
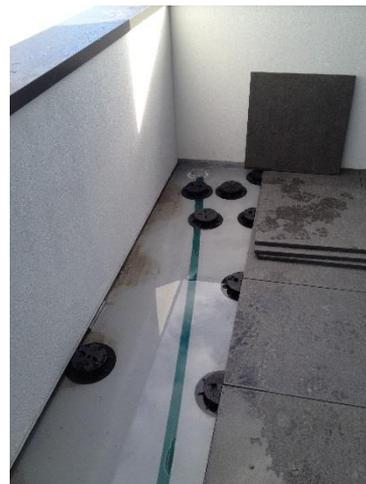
The connector is made from PVC pipe with a slot cut into it to take 5cm wide Capiphon belt. The connector was sealed into the drain pipe and the belt inserted into the slot and sealed above and at the sides with silicone sealant.
