# CASE STUDY

## The weekend's 180mm of rain we copped ...

Location: Terry Hills, New South Wales

The Challenge: An ordinary "pocket handkerchief" lawn in the backyard where the lawn is dying from waterlogging, even in a dry year.

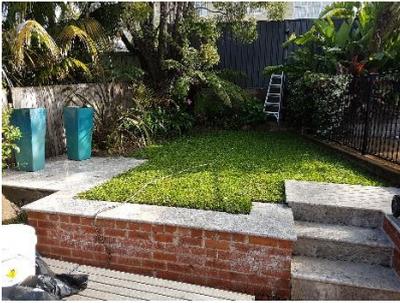
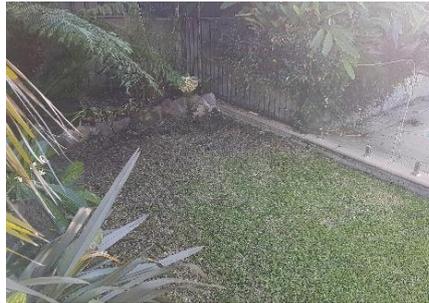
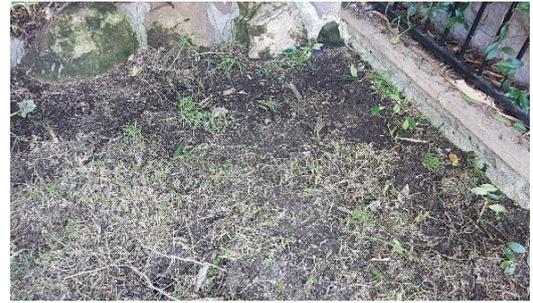
"The back right corner of grass in front of that ladder is where the main problem is. My feet sink in to the lawn it is so wet.

"... the grass in the back half of the lawn is now all but dead, or hanging on for dear life. The front half is not too bad as it has a very thick layer of soil I built up when building that front retaining wall

The back right is the highest point and there is a gentle ~2% grade so I'll fall it all to the left and down to bottom left exiting beneath a retaining wall in bottom left of photo."

**These suggest installing an intercept drain running along the top of the lawn area, making sure that the trench is deep enough to intercept any flow from next door or through the rocks.**

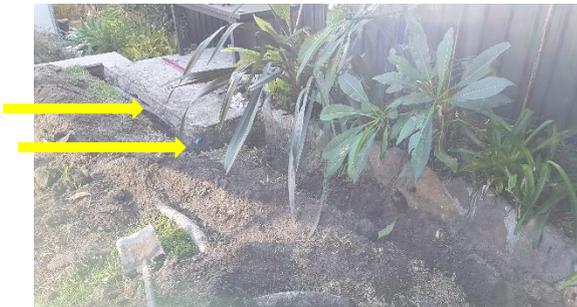
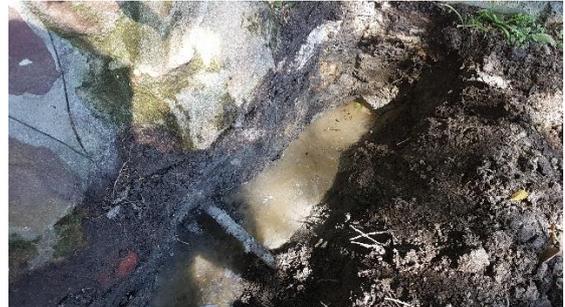
When the owner started to dig, the first to note is that the position of the Ag Pipe too high. The second is the amount of water at depth.

"So it certainly works for the surface water, but I'll know in a years time if it is addressing capillary water originating from 500mm depth."

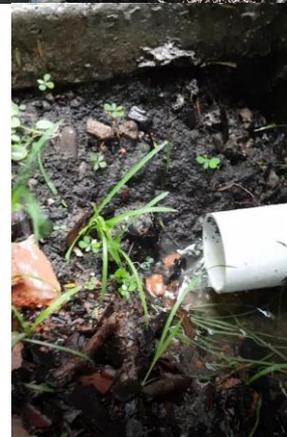
"Anyway here is the silver lining and highlight to the weekend's 180mm of rain we copped through Terry Hills."
