CASE STUDY

Waterproofing & Boundary Issues

Location: Greenway Avenue, Lenah Valley, Tasmania

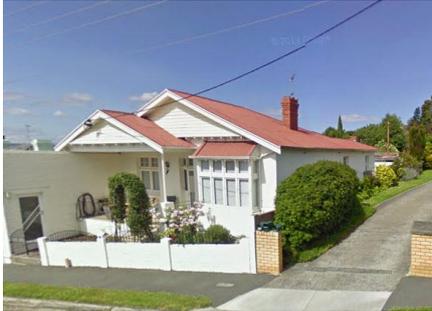
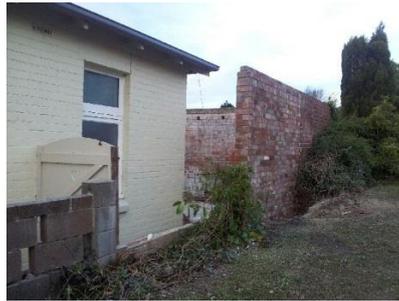
An owner-builder engaged an architect to design an extension to his 1930s suburban house utilising part of an existing outbuilding. Difficulties arose when the building surveyor pointed out that the walls of the outbuilding to be retained were, in fact, right on the boundaries of two neighbouring properties. This meant that the proposed drainage around the new extension would not be possible because it would have to be sited on the adjoining properties.

The owner was faced with the prospect of pulling down the walls and building new walls with drainage on the outside, not to mention the cost of new boundary fences. The major disappointment, though, would be the loss of space in the new room.

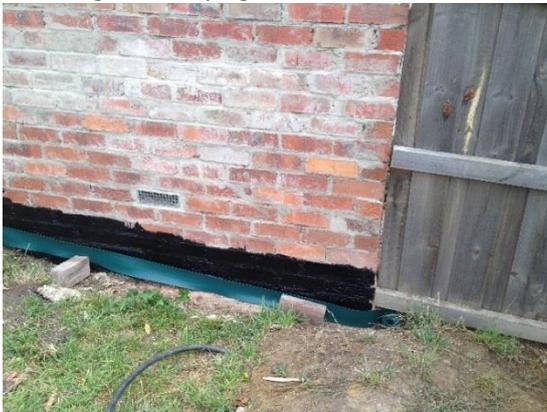
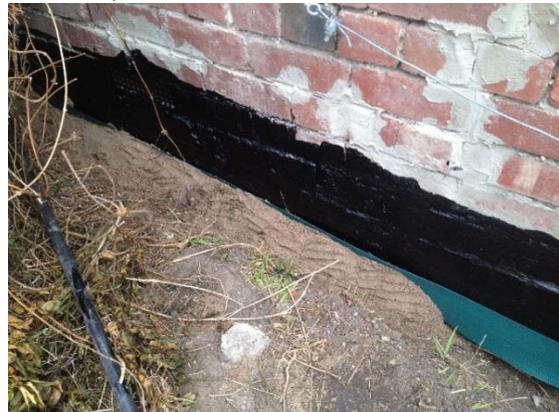
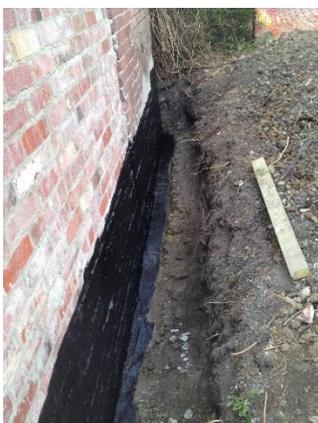
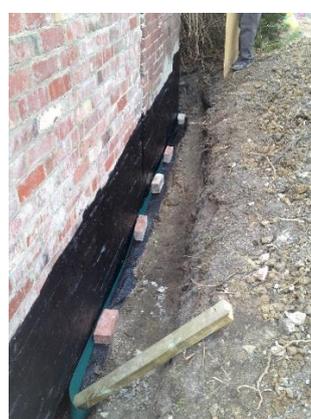
John Weston, ([John Weston Architectural Design](#)) had seen Capiphon in action and suggested that it could be used on its edge to provide drainage without taking up space on the neighbouring properties. The soil against the walls was excavated and the walls cleaned and dried before tanking with a liquid membrane. Capiphon belt was then laid on its edge directly against the wall and held in place with bricks or pieces of timber.

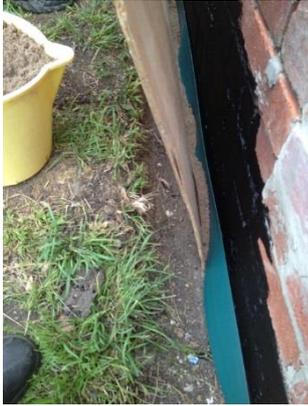
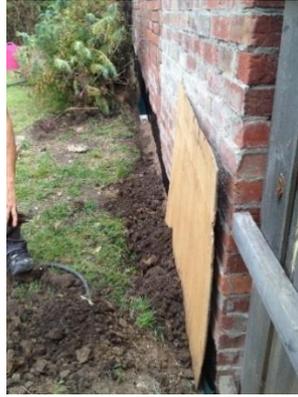
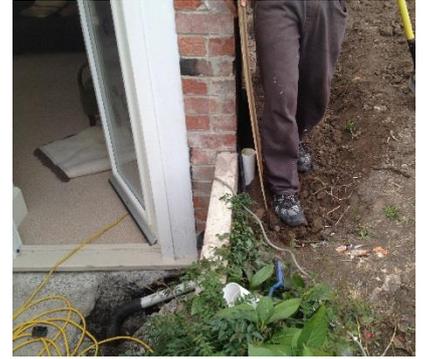
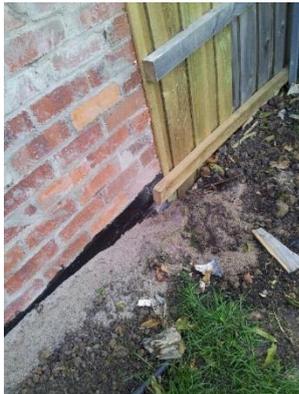
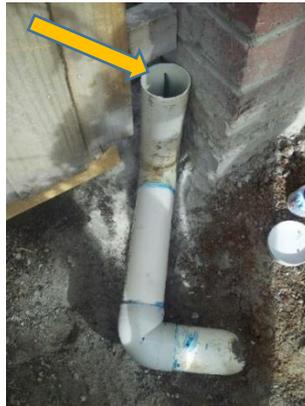
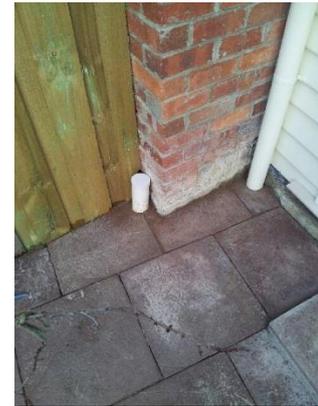
Coarse sand was then poured down a piece of form plywood to cover the belt while pinning it to the wall at the same time. The spoil (excavated soil) was then heaped up against the plywood. This resulted in a 3-4 cm wide vertical layer of coarse sand against the wall.

The Capiphon belt from the neighbour's side hidden by sand; the belt poking between the wall and the fence, and into the stormwater pipe (arrow); and the finished job.
